THE INFLUENCE OF NATURAL CLIMATIC FACTORS ON THE GEOMECHANICAL PROPERTIES OF SILICEOUS LIMESTONES FROM KAZIMIERZ DOLNY (POLAND)

Joanna Pinińska, Alicja Bobrowska, Dominik Łukasiak

Abstract

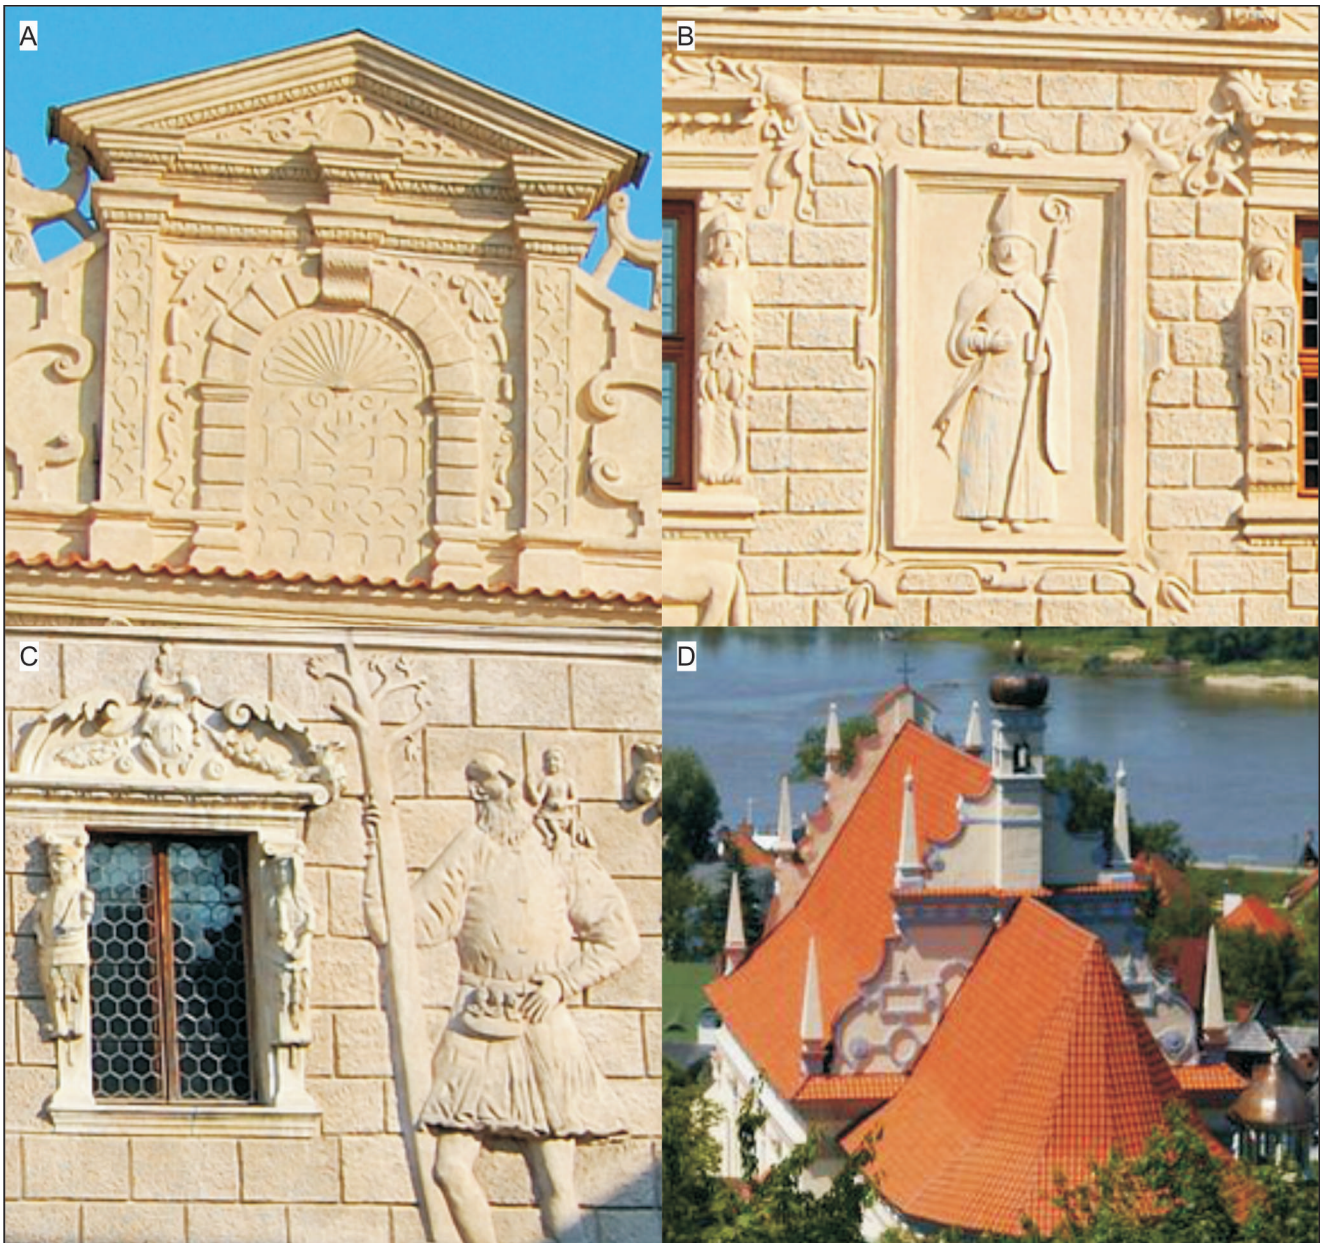
Fig. 2. A, B, C – Ornamental facades of Przybyla brothers' town houses at St. Christopher Street (ca.1615); D – church of St. John the Baptist (1586–1589).

The origins of the settlement date back to the 11th century. They were initially associated with the Order of the Benedictines and afterwards the Order of the Norbertines, which gave the settlement the name of Kazimierz, recorded for the first time in 1249. The founding of the city and the construction of a fortified castle is attributed to the Polish King Kazimierz III the Great. In the first half of the 14th century, the Polish King Władysław Lokietek founded in the city a parish church and awarded city rights. A market and streets and plots of land for residential construction were demarcated. Kazimierz Dolny flourished in the 16th century, when the grain trade with grain floated by the Vistula to Gdansk developed and, after numerous fires, wooden buildings were replaced with brick architecture. In this period lavishly decorated granaries, town houses and religious buildings were built. In the history of medieval stone building the strongest footprint was made by Upper Cretaceous opoka, exploited directly within the area of the city of Kazimierz Dolny, and also in nearby Piotrawin, Nasilow, Janowiec or Bochothnica. Situated in vicinity, accessible, easy for treatment, the rock allowed for extremely varied decoration of facades with an individual character proving the craftsmanship and high aspirations of the then masters of construction (Fig. 2).

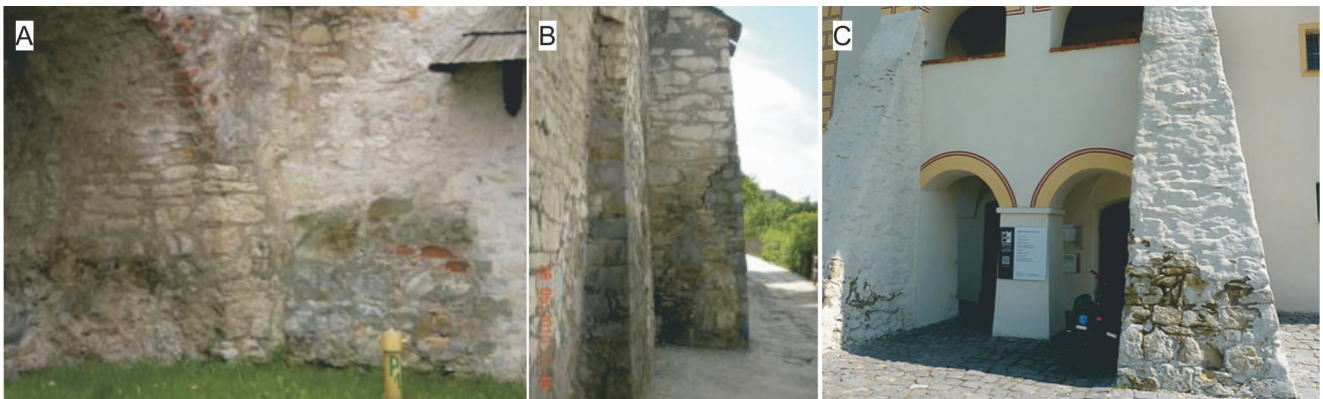
Fig. 6. Humid and discoloured parts of a walls: **A** – the castle stone walls, **B** – displacement of the walls on the steep slopes, **C** – opokas walls of a former granary covered with plaster.

The results of observation of the opokas in the historic buildings of Kazimierz Dolny lead to the conclusion, that the most common mechanisms of deterioration of their stone walls due to the aging processes are: change of wall tint, loss of wall bricks and their mortar (Fig. 6).

The damages of the opoka walls of the monuments are related to the penetration of corrosive water solutions into the cracked blocks and the invasion of microorganisms, both changing the colour of the stone and causing crushing and loss of mortar during the seasonal climatic changes. Lack of proper drainage and location near the steep slopes causes instability of their foundation and cracking of stone walls. Ad-

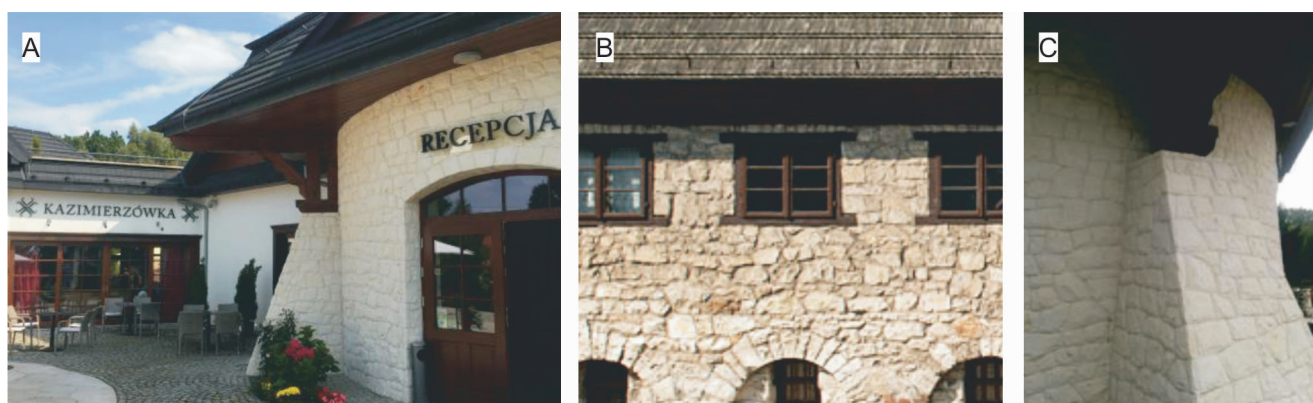
Fig. 7. A – Fragments of a modern hotel in Kazimierz Dolny; B – a renewed synagogue; C – a stylish retaining wall protected from rain and moisture.

In modern time the new technologies and the development of global distribution of decorative stones superseded the medieval prevalence of opokas in the regional construction industry. However, the former splendour of Kazimierz Dolny is being restored in a modern form. In old medieval granaries, hotels are being set up, the reconstruction of the fortified castle with the use opoka wall is quickly progressing, and in local, stylish buildings, outskirts of the old town the opoka starts to dominate (Fig. 7).
